Timber Pest Inspection Report

22 Carrington St, Seven Hills, NSW 2147

Inspection Date and Time: 08-Jun-12 2:00:00 PM

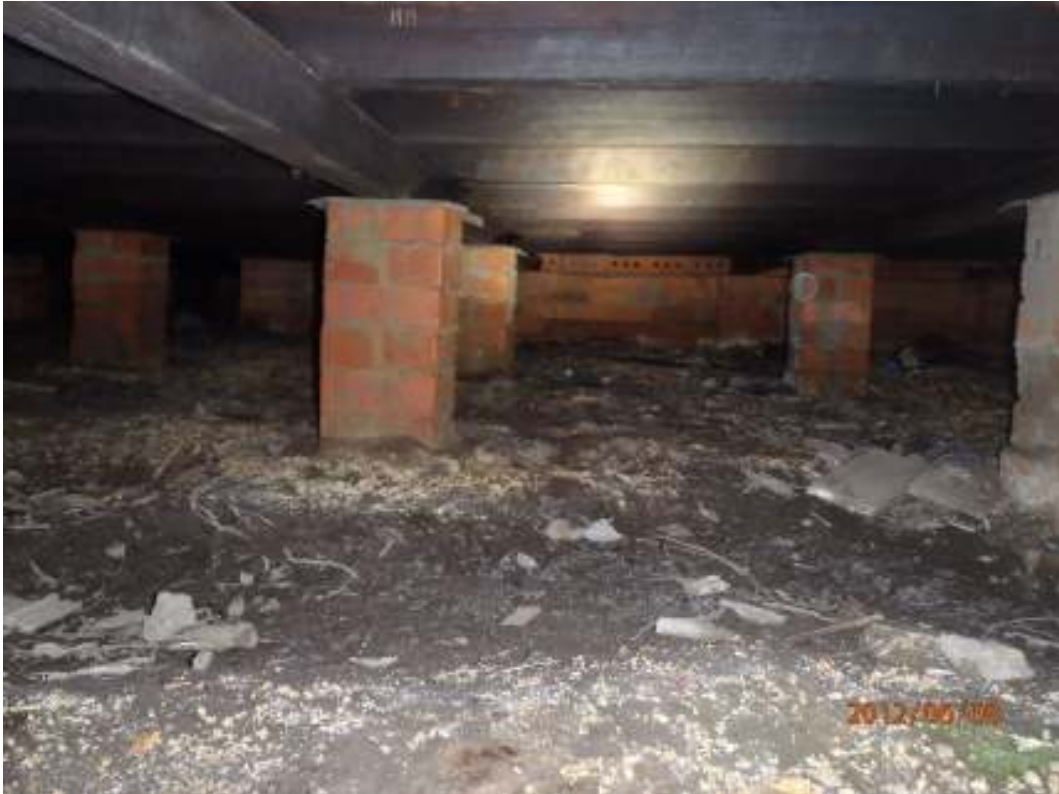
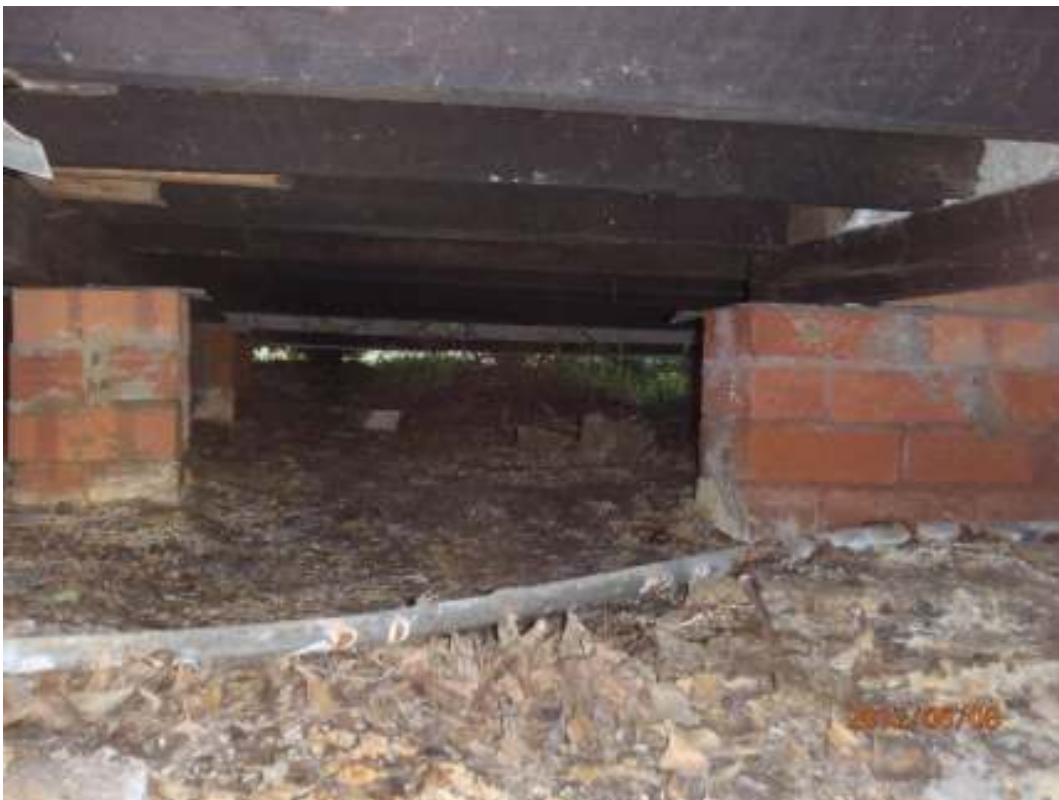
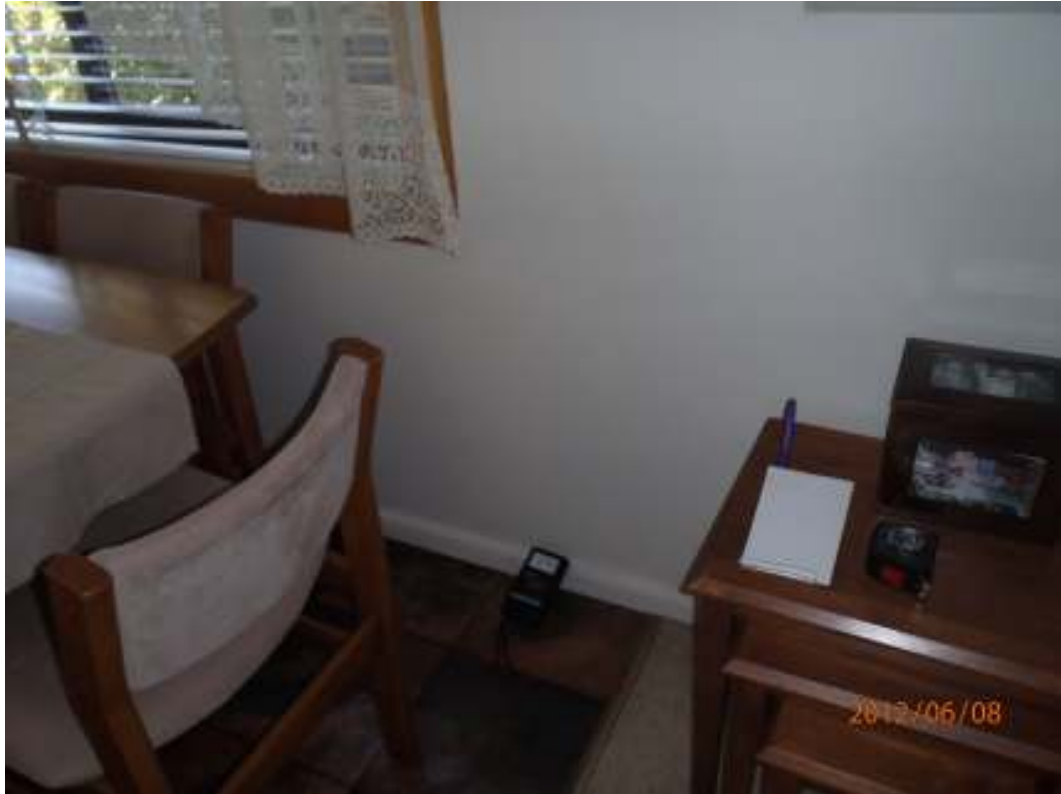
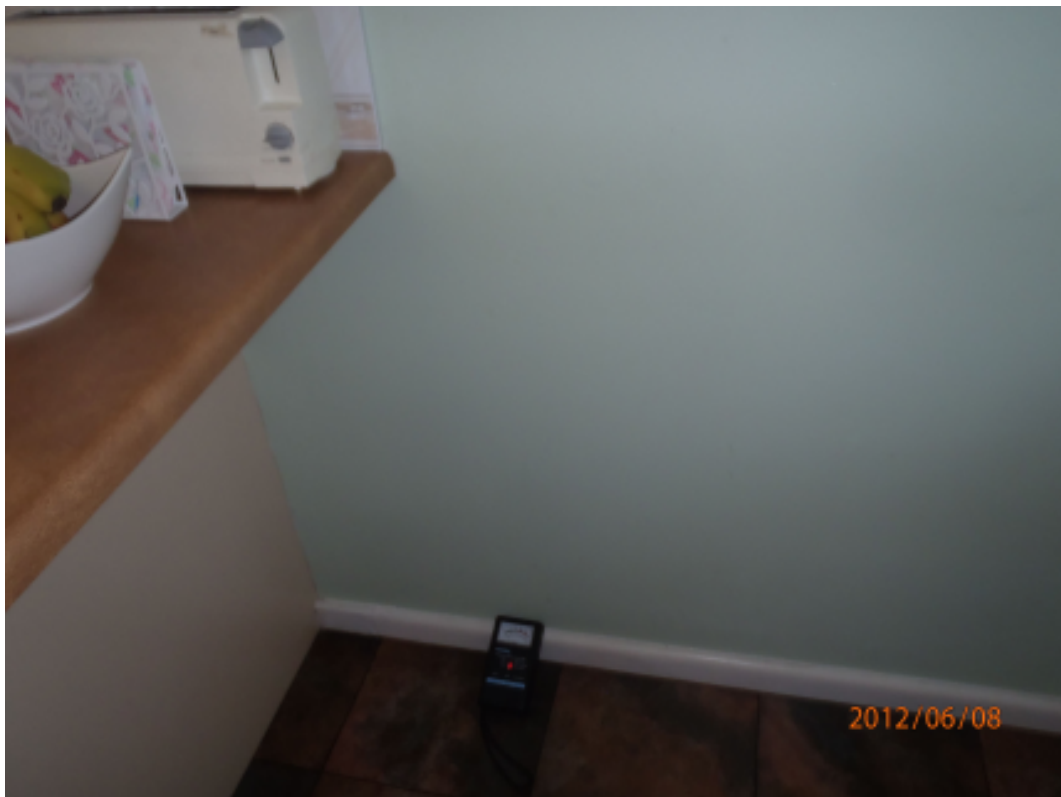
Photos for Undetected Termite Risk Assessment

The termite risk is moderate to high due to excess moisture in the sub floor area and high moisture metre readings detected in various areas of the property.

It is recommended a Aggline drainage system is installed to the front and side of the property to prevent water entry to the sub floor area and the detection of high moisture metre readings..

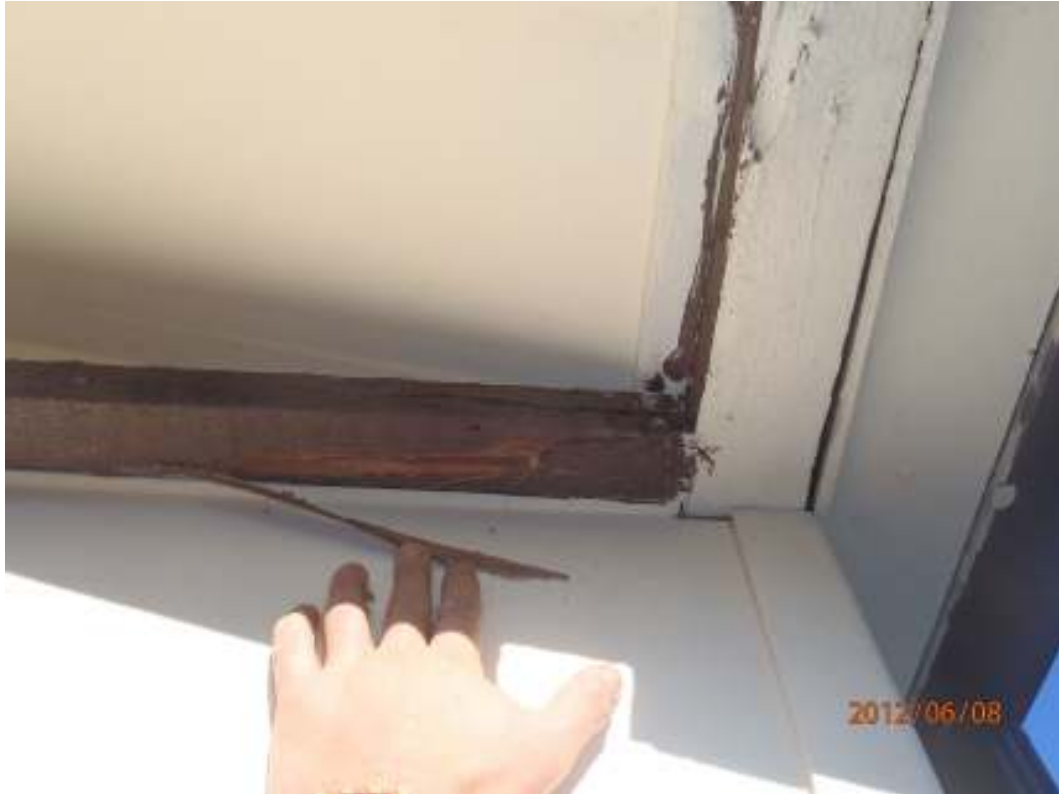
Photos for Termite Workings and/or Damage

Evident non active termite damage sighted to the external timber of the garage.

Where evidence of damage to building timbers exists, competent advice (e.g. from a licensed and practicing building contractor) should be obtained to determine the extent of any structural damage and as to the need or otherwise for rectification or repair work. See also *Item 3.5 - Frequency of Future Inspections* recommendation.

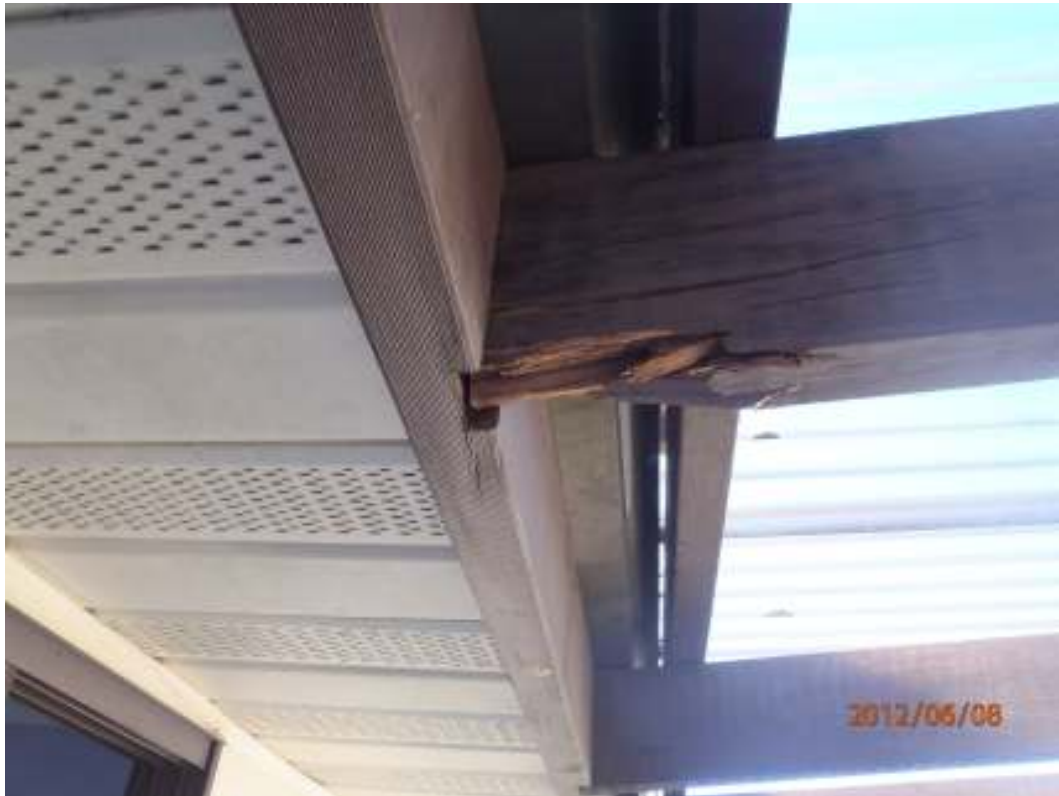
Photos for Wood Borers

Evident borer damage sighted to balcony awning. No treatment is recommended.

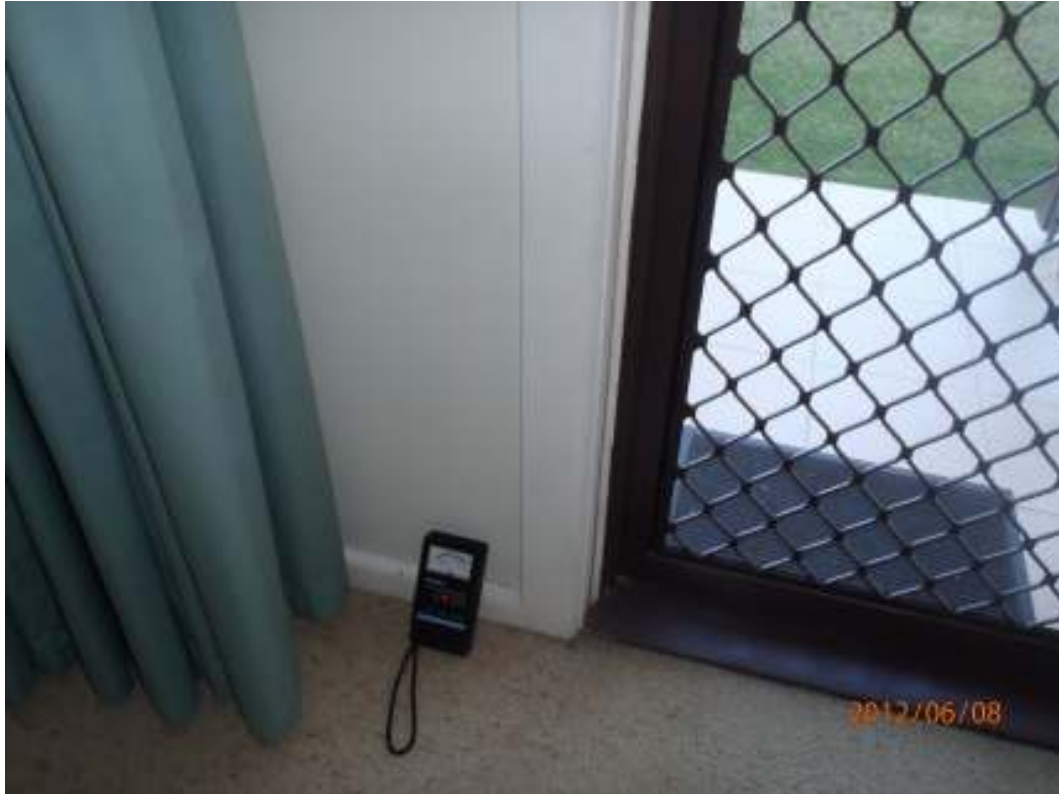
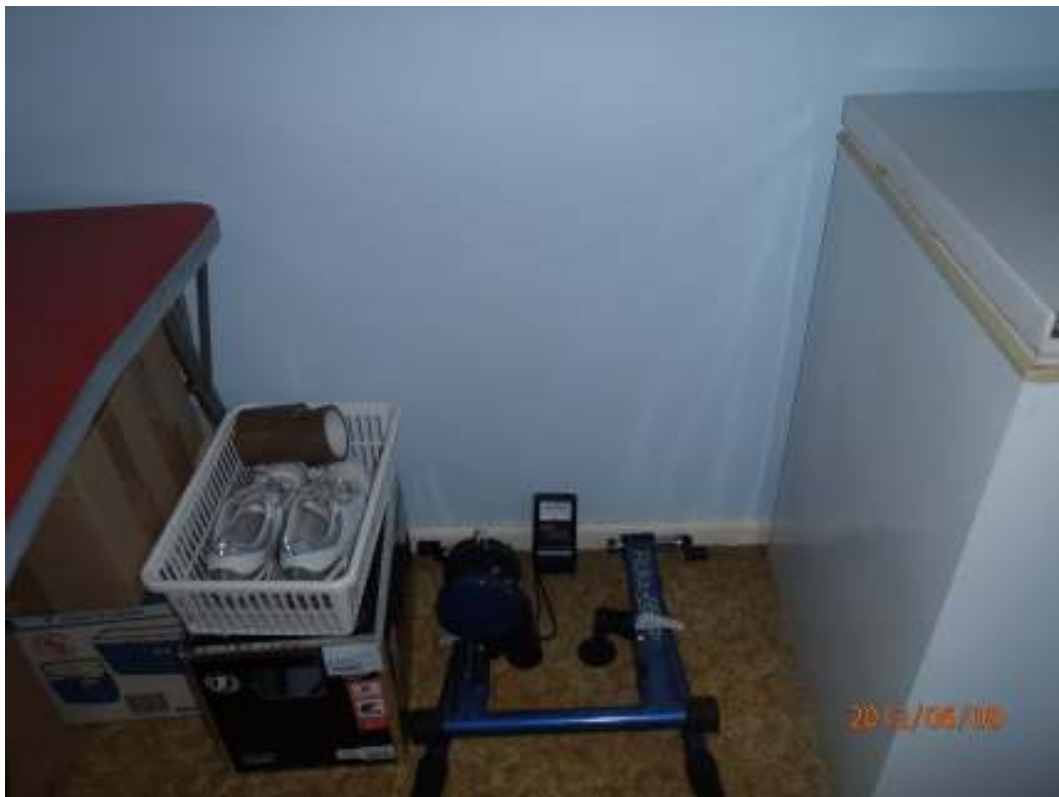
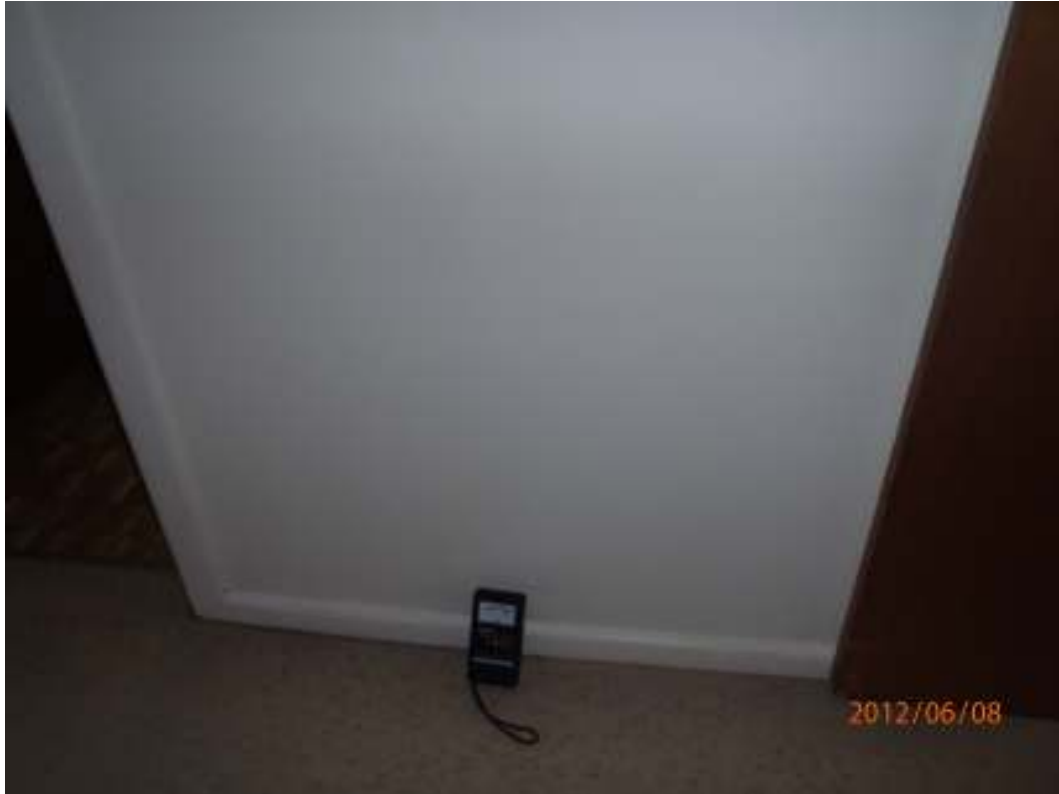
Photos for Presence of Excessive Moisture

Evident excessive moisture sighted within the sub floor area due to lack of drainage.

Evident high moisture meter readings was detected in various areas of the property. It is recommended a Aggline drainage system is installed and water leaks are fixed.
